TRANSPORTATION SAFETY

REFLEXIONS

Issue 19 – November 2003

Vandalized Switch

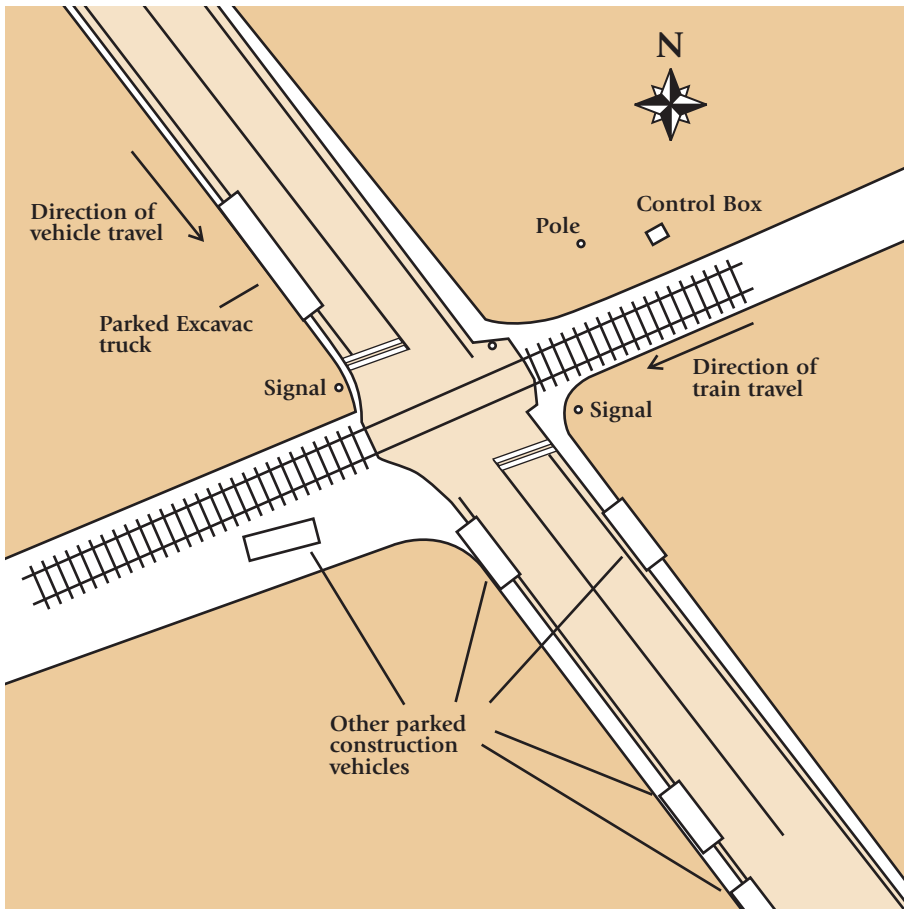
Layout of the accident site.

Rules certification and experience and after further orientation regarding GEXR safety policies, GEXR rescinded the work stoppage. When work resumed on 19 September 2000, nine days before this occurrence, 360networks had assumed all train control and motor vehicle flagging duties to complete the installation of the fibre optic cable. In addition, the 360networks’ supervisors were responsible for implementing safety procedures at this construction site.
